QUICK REPORT ON THE SEPTEMBER 26, 2003 TOKACHI-OKI EARTHQUAKE, JAPAN

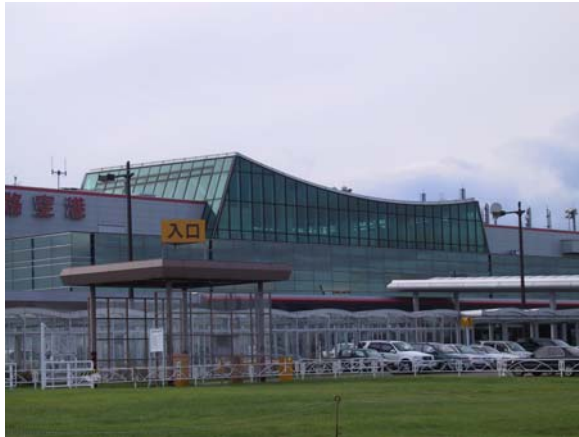
The Tokachi-oki Earthquake in 2003 occurred in the early morning on September 26, 2003, which caused large-scale falling down of departure lobby ceiling of the Kushiro airport terminal building. The Building Research Institute (Building Research Institute) and the National Institute for Land and Infrastructure Management (National Institute for Land and Infrastructure Management) surveyed the earthquake damage.

The three edges (north, south and east) of the ceiling were separated from surrounding structural elements and only the west edge was rigidly connected to the structure. Due to the pounding of the ceiling to the west structural frame, a large area of the ceiling fell down. No one was injured due to the early morning shock.

Photo 2 Outside view of airport terminal building
